# STRENGTHENING A WELLINGTON LANDMARK

The old DIC Building on Lambton Quay gets a different kind of makeover

**O**ne of Wellington's landmark buildings is undergoing major seismic strengthening. The former DIC Building, now Harbour City Centre, 179-193 Lambton Quay was built in 1928, before earthquake performance codes existed.

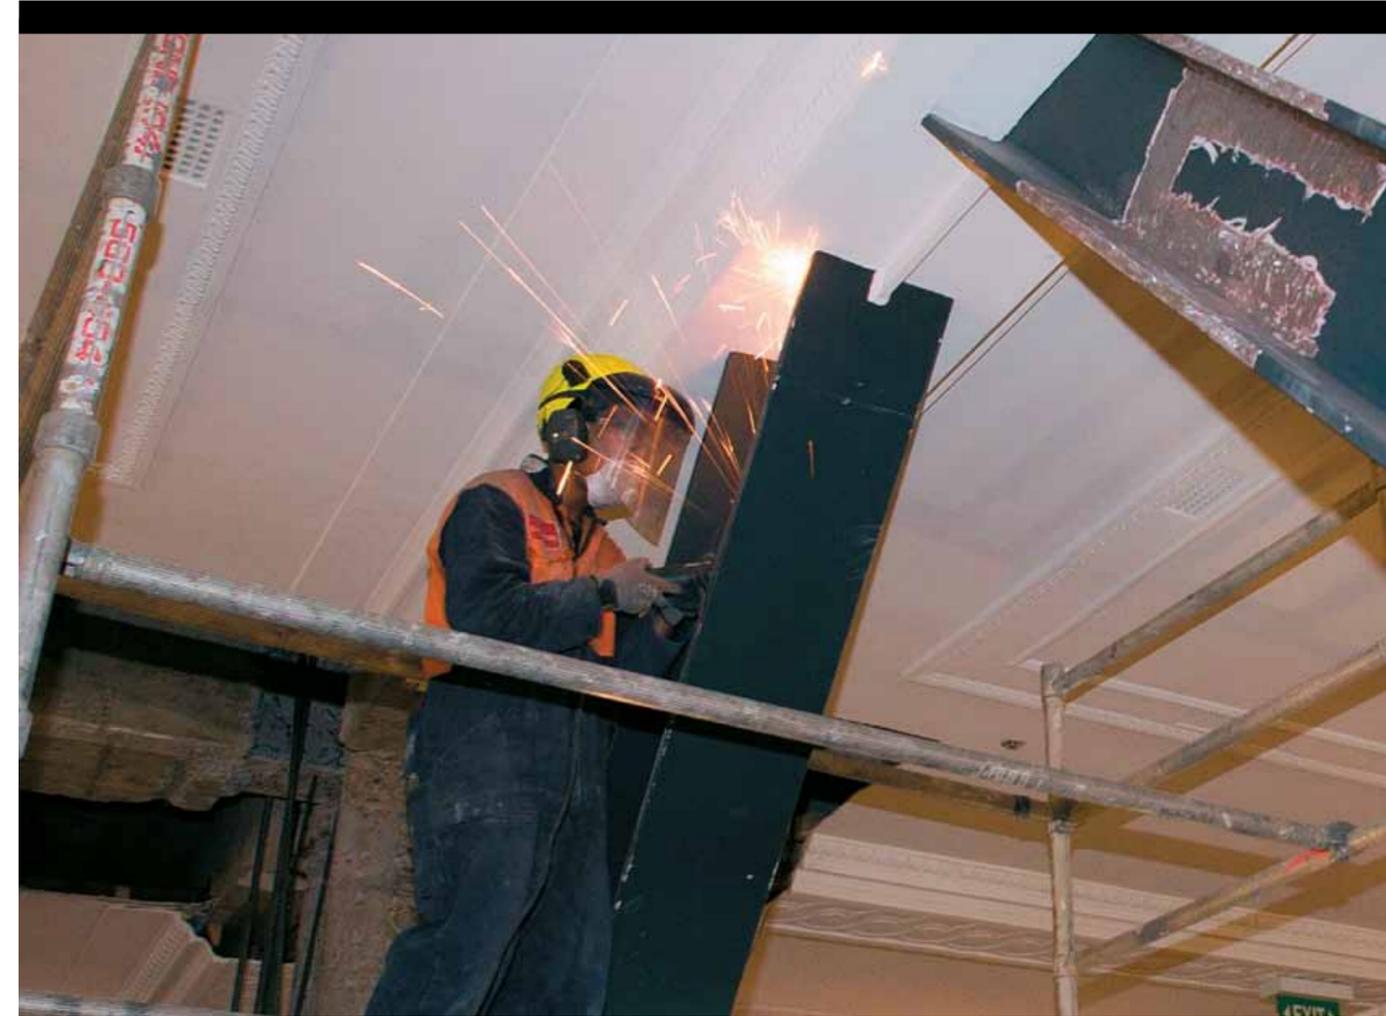
V-frame braces with dampers inserted were visible on Level 1 as were columns in various stages of improvement – from the original steel, stripped of the old fireproofing concrete, through to reinforcing, timber formwork and the finished columns. New, self-compacting concrete lends additional strength to the

columns.

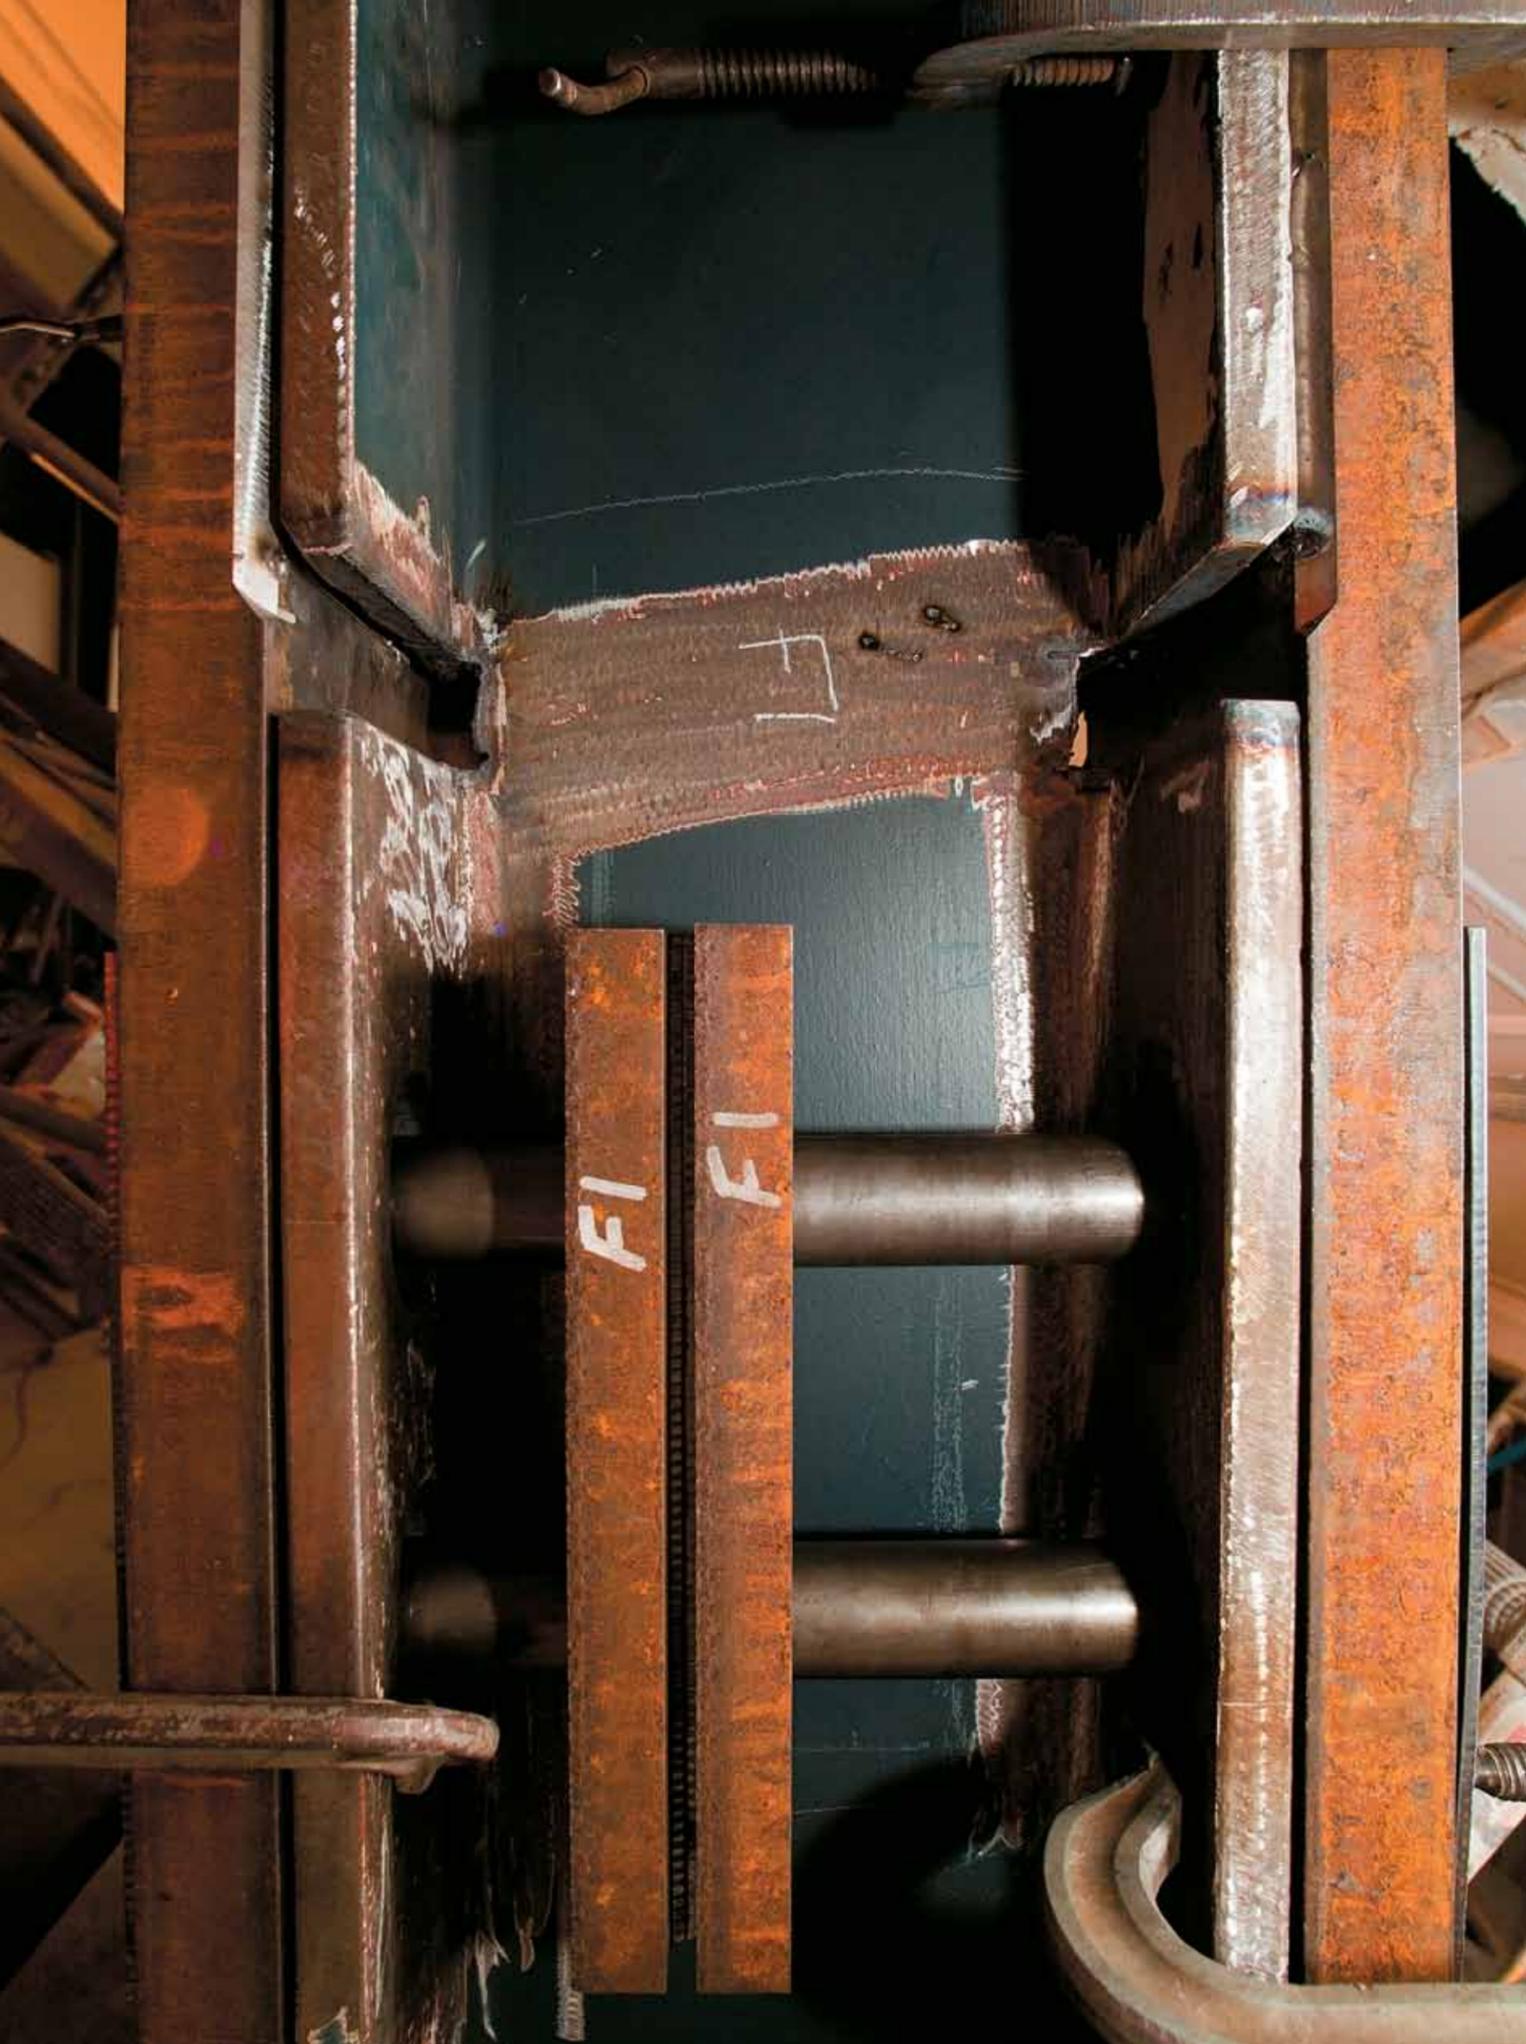
**LEFT: NEW, SELF-COMPACTING CONCRETE LENDS ADDITIONAL STRENGTH TO THE COLUMNS. ABOVE: DAMPERS FITTED TO THE V-FRAME BRACES LIMIT HOW MUCH LOAD COMES INTO THE BUILDING AND PREVENT THE BRACES FROM BUCKLING.**

The method adopted to strengthen the columns also took account of the tenants. Columns are reinforced and concreted

from the lower floors going up, to meet the other part coming down where they are joined by couplers.

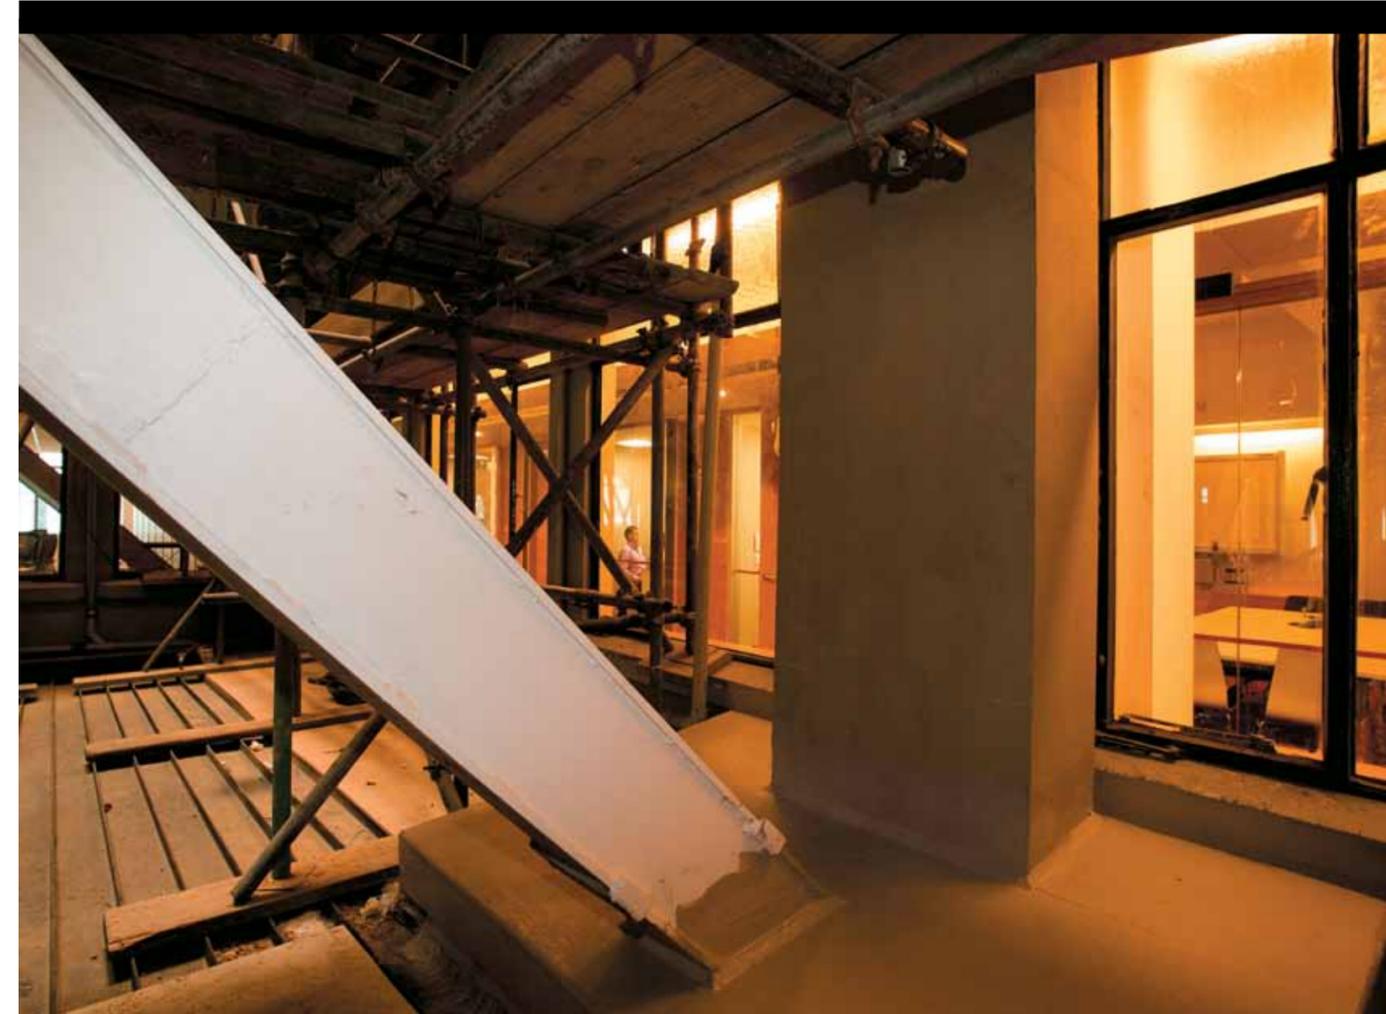
limiting how much load comes into the building and preventing the braces from buckling.

They absorb the energy of the shaking and dampen the response of the building. The other primary structural elements within the building are then checked to ensure that they have capacity in excess of the damper yield loads. This hierarchy of strength avoids yielding where it is not expected.

Every brace is connected into the base of a column. Anchor piles with high-tension capacity have been added to provide extra foundation strength.
